LEHIGH RIVER BASIN,
POHOPOCO CREEK, PENNSYLVANIA .

BELTZVILLE LAKE.

CONDITION REPORT. DAM, OUTLET WORKS & SPILLWAY PERIODIC INSPECTION REPORT, NO. 1,

JULY 1970.

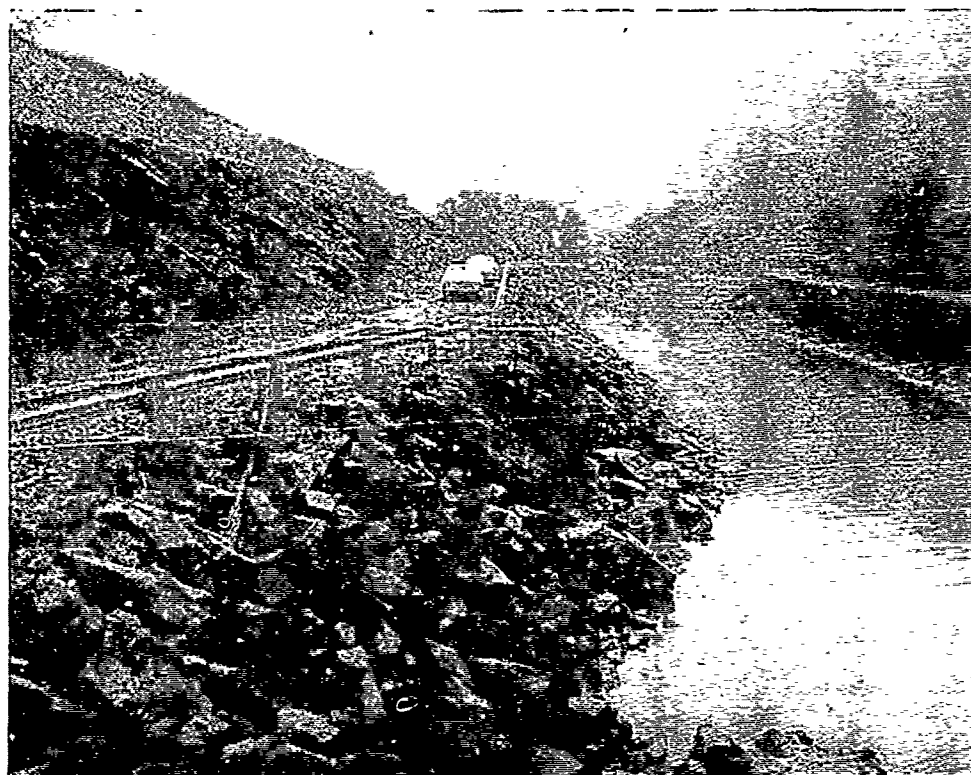
(3) Outlet works area: Photographs 6, 7 and 8 show areas of possible future erosion problems and were taken for comparison purposes only. Captions identify the area.

Photo No. 6 Potential undermining of guard
rail downstream of outlet works.

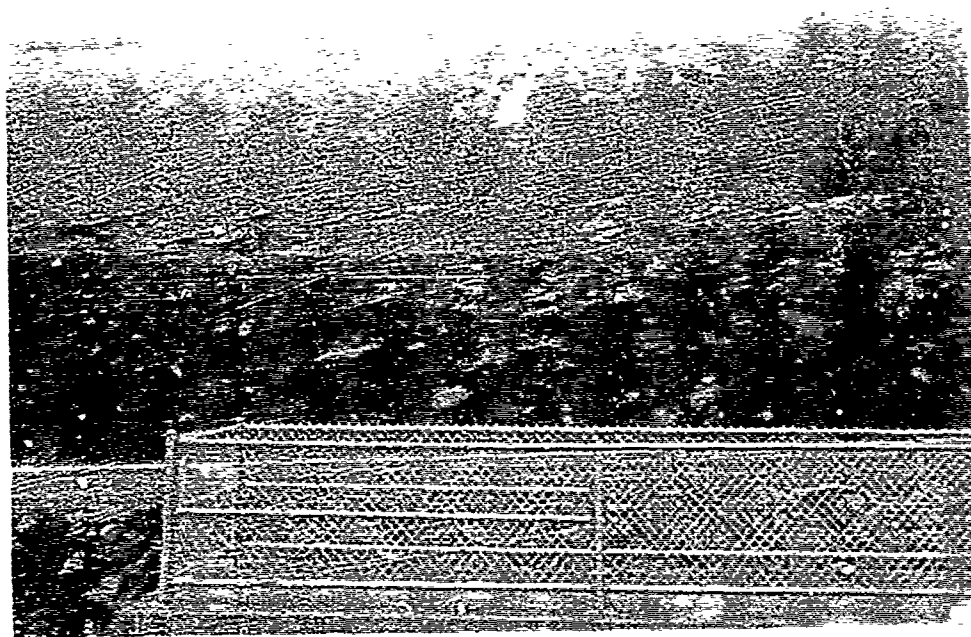
Photo No. 8 Eroding of overburden down to
bedrock - right bank above
outlet works.

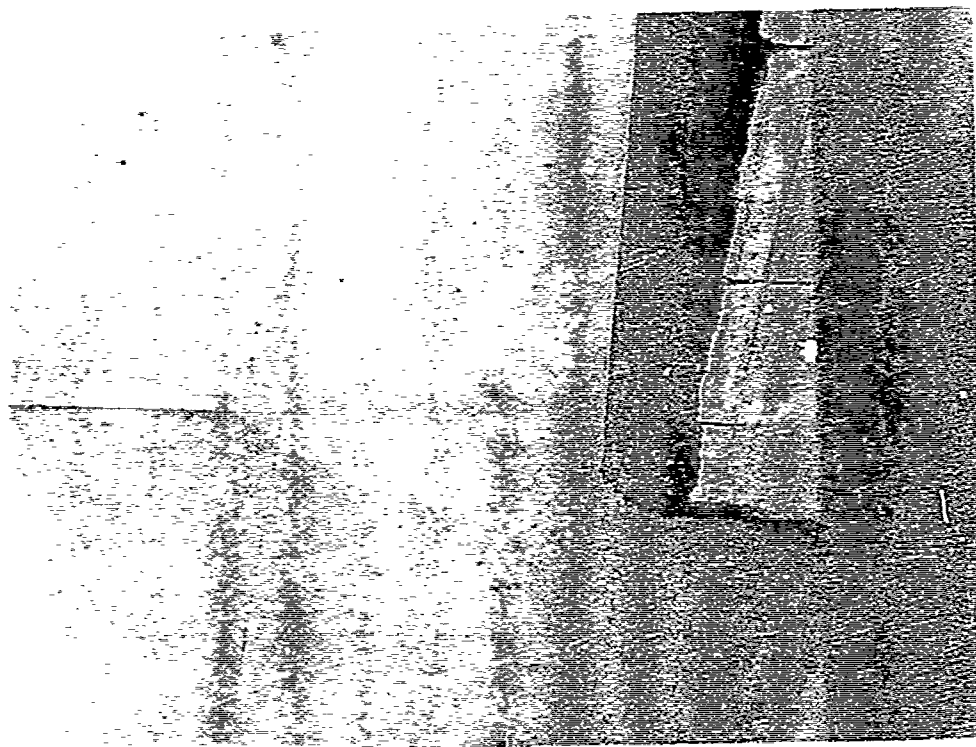
(2) Bridge piers: Some minor extrusion of joint filler has occurred between the right spillway bridge pier and the spillway slab but does not present a problem at this time. No repair is contemplated. Extent of displacement can be seen on photographs 10 and 11.

Photo No. 10 Extrusion of joint sealing
compound between spillway
bridge pier and spillway slab.

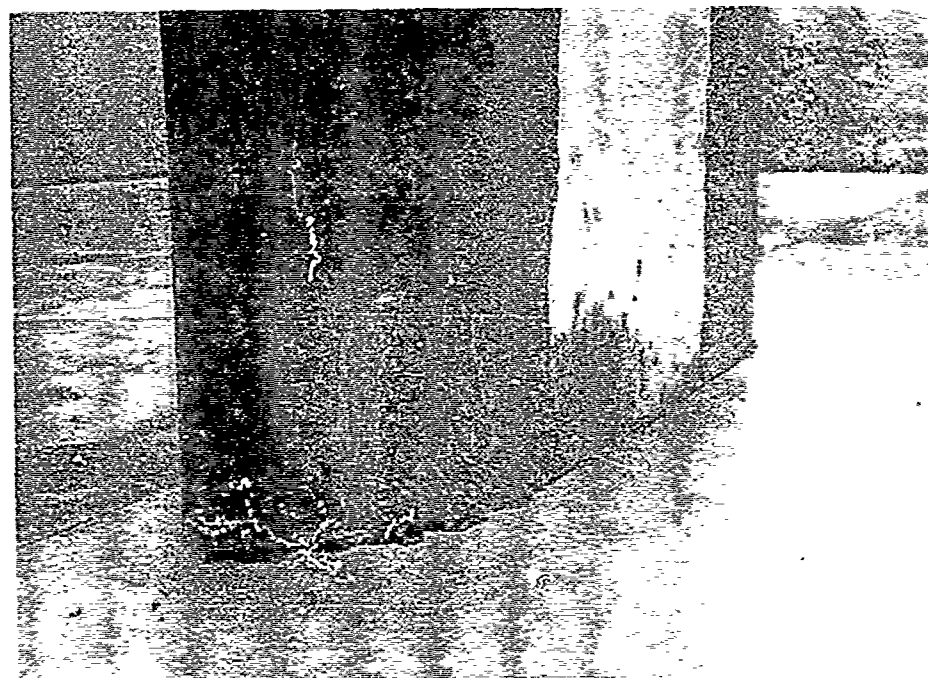
Photo No. 11 Extrusion of joint sealing
compound between spillway
bridge pier and spillway slab -
closeup view.

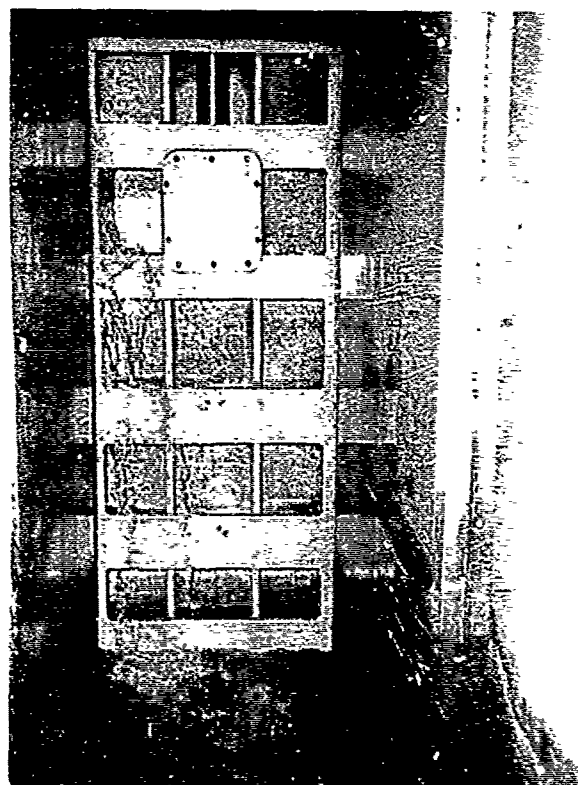
Photo No. B-2 View of gate in South Chamber.

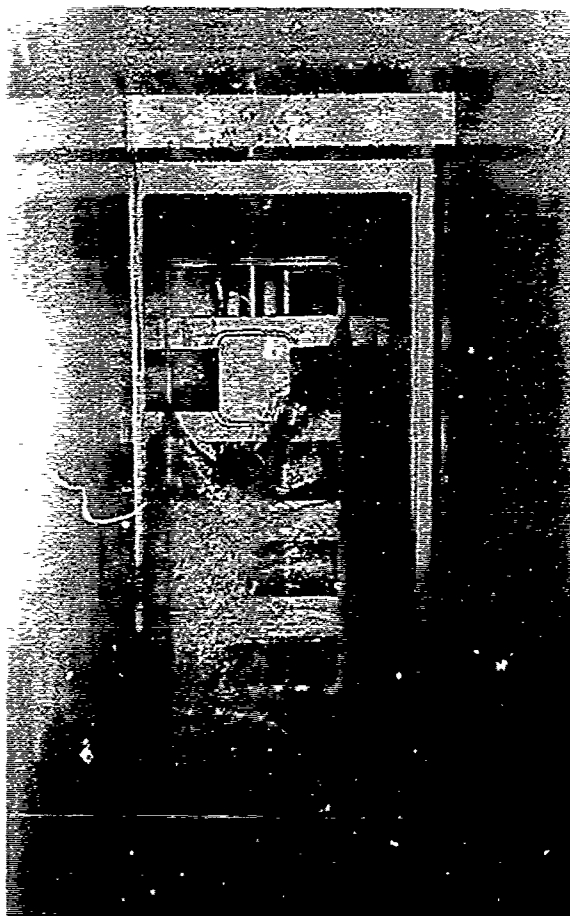
Photo No. B-9 View of gate in North Chamber.

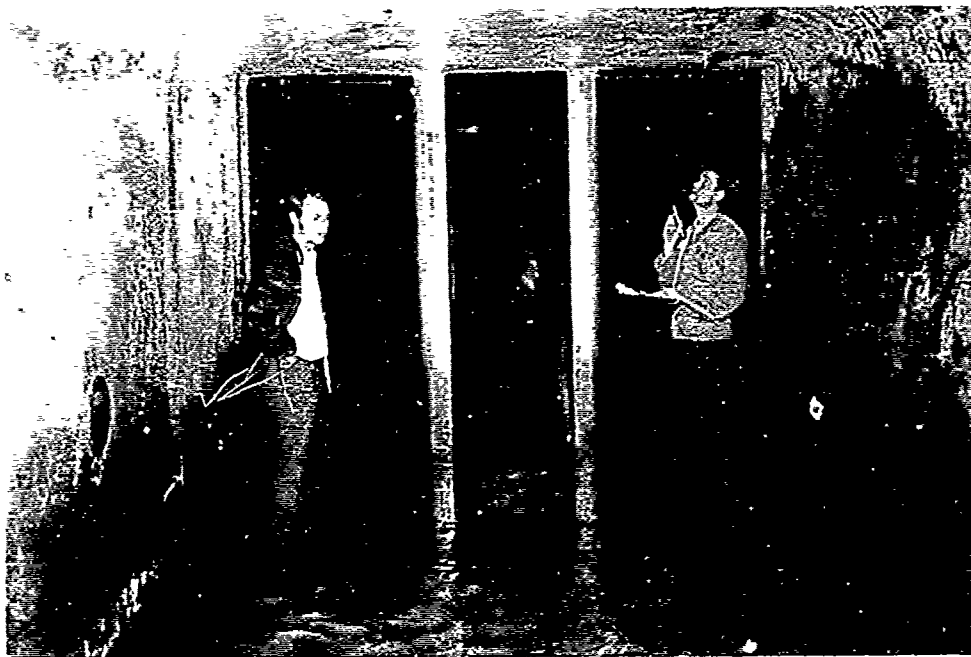
Photo No. B-11 View of Chambers. Note mud
deposit in center chamber
(water quality control outlet).

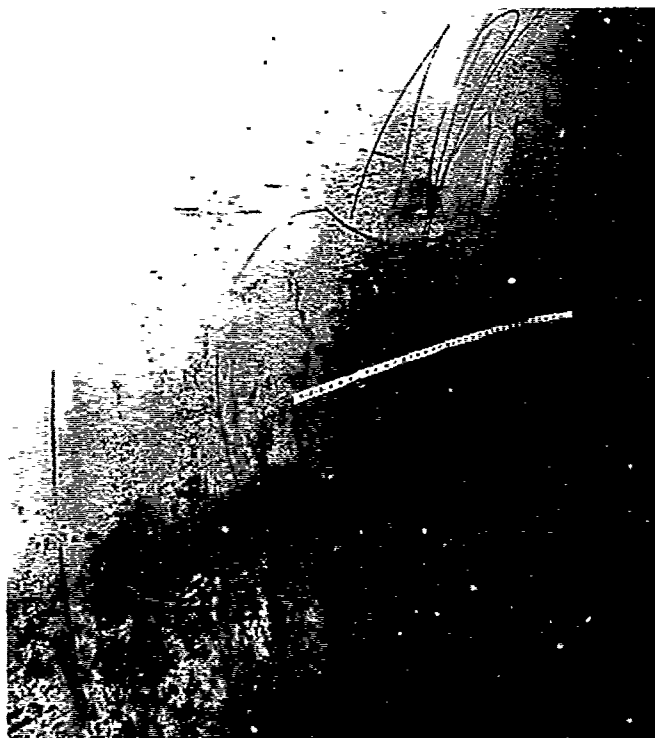
Photo No. B-12 Air voids zone in south wall
conduit between Sta. 4+47 and
4+50.
